## Conceptual Investigation of the Northridge's Earthquake Structural Failures on Steel MRF by the Aid of the Swiss Cheese Model

Anthimos Anastasiadis, Marius Mosoarca and  
Antonio Formisano

May 20, 2024

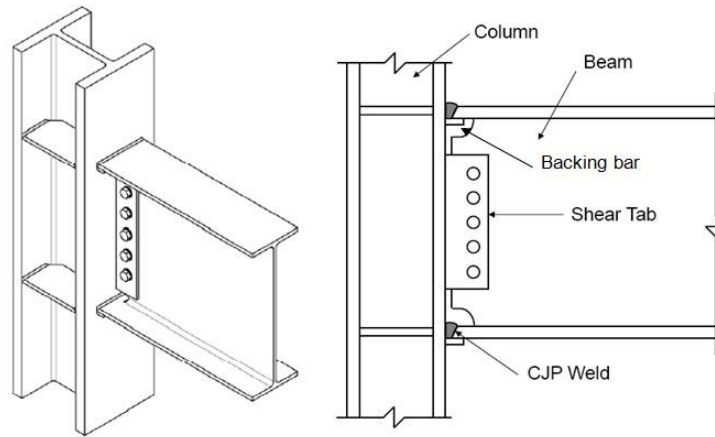
With the advent of welding in the 1960s, as well as with the buildings becoming taller or having greater spans, hence requiring greater capacities, it was the moment that was introduced the welded beam-column connection Fig. 1 (the flanges of the beam are site welded with complete penetration welds, with the aid of backing bars, and a bolted shear tab with or without welds at the corners at the beam's web). From that timeframe, the great majority, of the moment-resisting frames in the US, was designed and constructed using the connection details provided in Figure 1.

**Fig. 1** Typical WMRF connection in the early 60s until 1994 Northridge earthquake.

The Northridge earthquake (January 17, 1994), a seismic action with a relatively moderate magnitude of  $M_w = 6.7$ , unveiled the vulnerabilities of that type of structural system with this specific joint conformation (see figure 1). This happens, as with all things in real life, at the height of the trust that involved the moment-resisting frames with welded beam-to-column connections. The steel moment-resisting frames, gener-

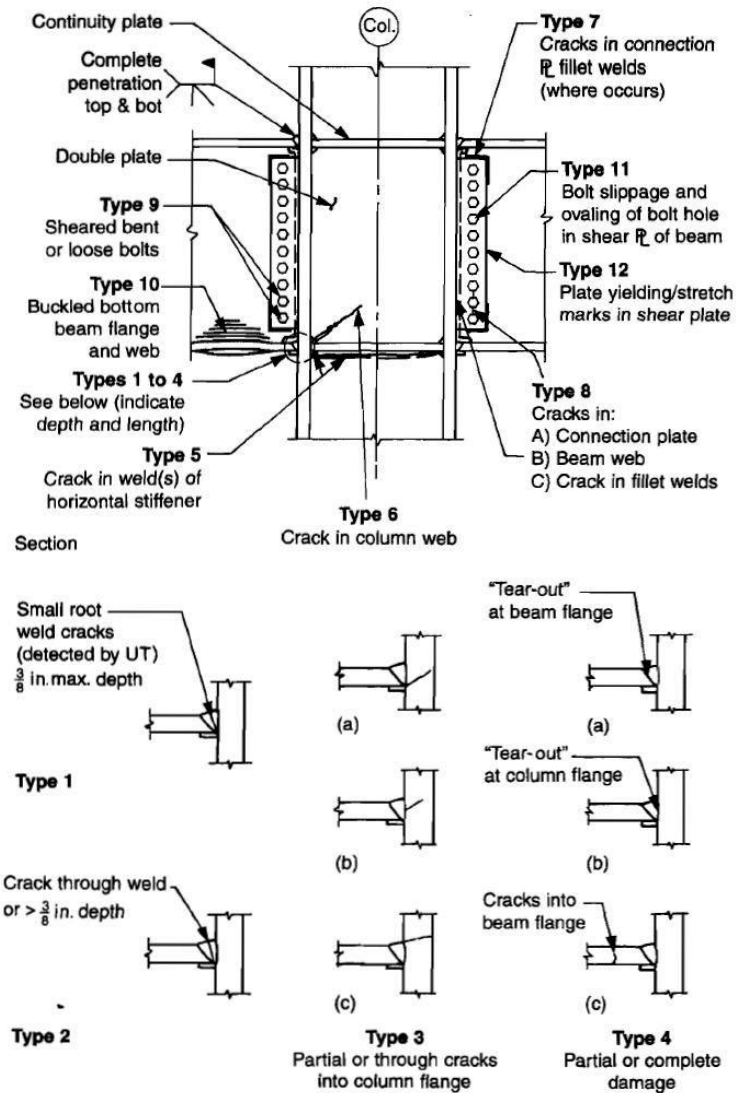
ally welded with the E70ET04 electrode type, behaved in a brittle manner and not in a ductile manner, as was the main expectation. More specifically, the beam-to-column joint behavior was brittle and damaged in different ways, as presented in Figure 3 [5].

Fig. 3 Unexpected brittle damage at the welded beam-to-column joint [5].

Focused on the causes that provoked the brittle fractures on WSMRF, the US engineering community did not unanimously accept a certain couple of factors that are attributed to the unexpected failures. Therefore, it is important to briefly describe the main factors observed for the in situ and post-Northridge experimental performance of WSMRF connections: (i) welding-related issues, concerning undetected welding factors such as low weld metal toughness, poor quality welding, inadequate workmanship, inadequate inspection, (ii) poor connection detail with very high localized stress and strain at the column-connection face, due to improper detailing, (iii) steel

material issues, where a higher actual yield stress than considered in design altered the strong column-weak beam in a weak column-strong beam; (iv) seismic load-related issues through the near field effect; (v) structural configuration-related issues through the reduction of structural redundancy by using also perimeter WSMRF while the other connections are pinned; the coupling of steel beam-slab effect, which also altered the capacity design conditions for a strong column and weak beam. It really was the combination of all the technical factors, or more than three of them, that led to the unforeseen damage.

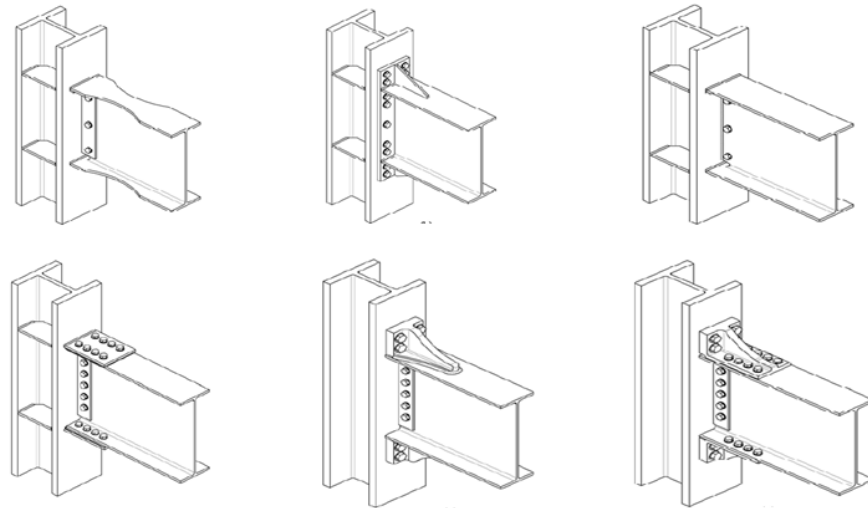
**Fig. 5** A sample of prequalified connections according to ANSI/AISC 358 [10].

research reports were published for the aid of practitioners and the steel industry [9]. Based on this work, the American Institute of Steel Construction, AISC, developed the following standards: (i) the ANSI/AISC 341 (Seismic Provisions of Structural Steel Buildings), editions 2002, 2005, 2010, 2016, and 2022, and (ii) the ANSI/AISC 358 (Prequalified Connections for Special and Intermediate Moment Resisting Frames for Seismic Applications), editions 2005, 2010, 2016, and 2022 [10]. Moreover, the American Welding Society published the AWS D 1.8 (Seismic Supplement), which focused on materials, connection details, workmanship, and inspection issues. Nowadays, prequalified moment connections are completely codified, including non-proprietary and proprietary connections Fig. 5.

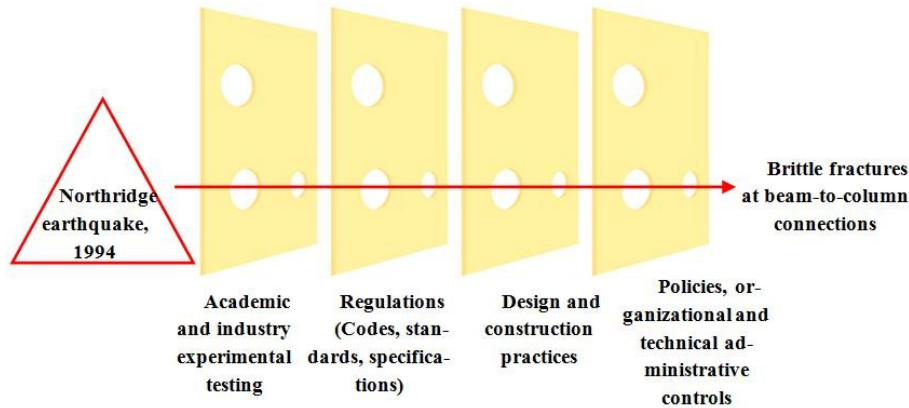
Starting to follow the trajectory from the pre-Northridge era to the Northridge earthquake incident, one can distinguish the next plane of action according to the Swiss Cheese Accident Model (Fig. 7). (i) Mainly, the first hole is related to experimental testing and, in a lesser way, to analytical studies. In the great majority of the experiments that had been carried out, in one way or another, the trend of the welds toward brittle fracture had become apparent [6]. Already in the first experimental program that implemented cycle loading, Popov and Pinkey (1969) pointed out the importance of welding quality and the corresponding inspection. Moreover, they also reported the importance of the size effect [6]. The experimental work of Engelhardt and Husain (1993), published a month before the Northridge earthquake, also warned about weld quality and control [6]. Early warning signals are ignored completely and

translated wrongly. It is noteworthy to note the following issue: the experiments conducted in the laboratory regarding welding conditions, beam-column section sizes, and slab effect have nothing to do with real construction conditions. This was a technical, communicative, and administrative failure. It was the beginning of the end. The second hole is related to the regulations (codes, standards, and specifications). The building officials and the professional bodies who are responsible for the drafting of regulations did not capture and embody the results provided by academic and industry research. At some point, they are constrained by other than technical reasons (e.g., political, financial, or industry interests) [6]. The 1959 Blue Book (SEAOC, 1959) considered as a dogma the ductility of steel structures. The 1968 Blue Book commentary (SEAOC, 1968), fortunately, recognized and imposed material conditions ensuring the ductility of steel frames. Moreover, this edition of Blue Book provides the first attempt at codifying WSMRF (introducing requirements for ductility and quality control in the welded joints). The 1976 UBC (Uniform Building Code, 1976) imposed stringent measures for welds' inspection [6]. The 1988 UBC defined the capacity design (strong column-weak beam). Finally, one of the major professional bodies representing the steel industry, the American Institute of Steel Construction (AISC), published the 1992 AISC, the first standard related to the seismic design of the welded special moment resisting frames. There was technical information, but it was not fully appreciated and was sometimes ignored. It is clear that the reporting and monitoring system for the evolution of the building regulations did not work very well; there was a lack of systematic technical overview. It is well known that in the USA there was not a harmonized framework regarding the structural design regulations; only in the 1990s and early 2000s did radical changes occur [13]. The third hole is related to the design and construction practices. The fundamental rule of thumb is to weld in the shop and bolt at the site. It violated a rule that generally can avoid or mitigate poor welding workmanship. Accordingly, every inspection process is undermined due to the fact that the welding is influenced by the environmental conditions, welder's capacity, position, and attitude; *"the weld quality is into the product"* and not at the inspection procedure. Moreover, during this time, designers reduced the redundancy by using SWMRF only at the periphery and/or at selected points of the plan configuration and pin connections for the interior frames. Overall, the final safety net to ensure safety is the administrative controls and the applied policies of building jurisdictions. Until the Northridge earthquake, it was not so active; after the Northridge earthquake, they emitted guidelines for the design, construction, and certification of welded connections in new steel buildings.

**Fig. 7** Swiss Cheese Model application for the damage in welded connections after the Northridge earthquake, 1994.

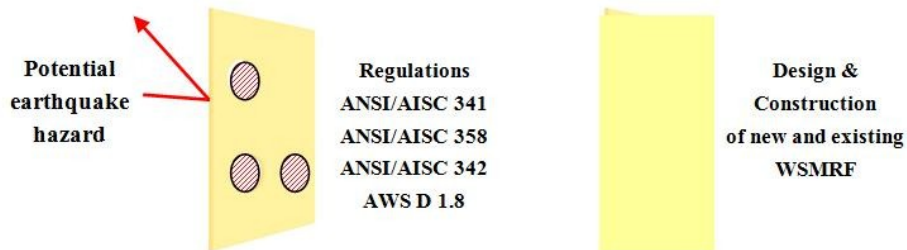
**Fig. 8** Swiss Cheese Model application for the brittle post Northridge earthquake period.

In the post-Northridge period, experimental testing, theoretical analysis, and numerical analysis provided by the SAC Joint Venture Research Program scrutinized the performance of the WSMRF, leading to a new era for the design and construction of steel. The ill-defined issue of welded moment connections was resolved with the prequalification of different types of connections (bolted, welded, reduced beam moment connections, proprietary joints) (ANSI/AISC 358). Further on, it was also regulated in the design of steel structures subjected to seismic loading (ANSI/AISC 341). Currently, the holes are filled (Fig. 8).
