## Assessment and Back Analysis of a Swaying-Jetty in Dumai Indonesia

Merdeka Tazakka, Adecar Nugroho and Budiwan Adi Tirta

January 29, 2020

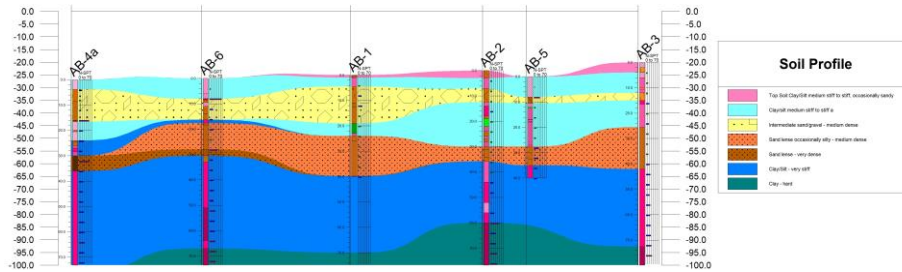
**Fig. 2.** Long Section of the new boreholes

Based on the new site investigation, it indicates that the top 1 - 2 m dominated by thick clay deposits with some gravel and sand in certain areas. The next 5 to 7 m consists of a soft to medium clay layer. The clay layer is considered as clay with high plasticity since the PI is 43 (Burmister, 1949). It followed with the medium-dense gravelly sand layer with a thickness of about 5 m. Below the gravelly sand layer, medium to hard clays with high plasticity layer is present until 90 m below the seabed layer, with another sand lenses of medium dense relative density, found at depth 20 to 40 m that varies in thickness. The mentioned stiffness consistency of all cohesive soils and the relative density of all granular soils are according to Peck and Terzaghi (1967,1996). The long section of AB1 to AB6 is presented in **Fig. 2**.

The new site investigation has brought a completely different view of the geotechnical condition on the main jetty area. The silty sand layer at depth 21 m to 40 m found in BH-1 (initial SI) is later on known as a local lens. The assumption that the dense silty sand layer will extend to a very deep layer is incorrect, confirmed by the new site investigation. BH-1, as used in the design, can not represent the actual condition due to the inhomogeneity of soil profiles in the waterfront area (Nugroho et al., 2019)

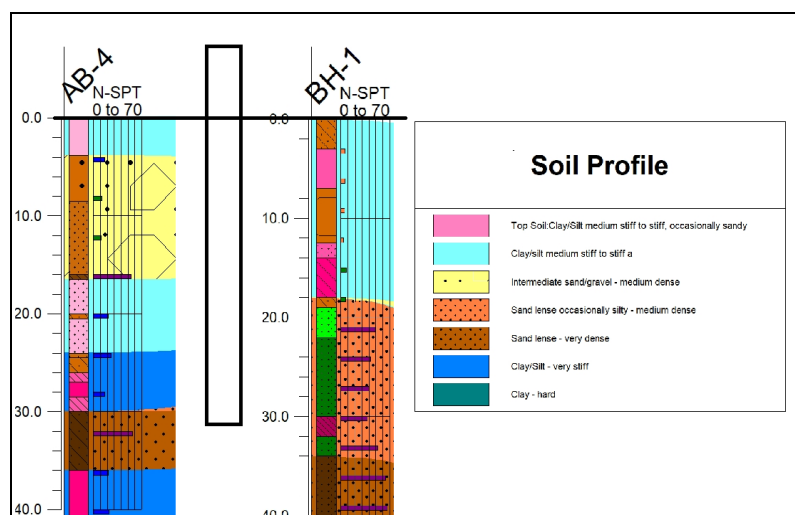
**Fig. 3.** Side by side comparison of design assumption and the actual soil condition

It is given side by side overview comparing new borehole AB-4 and BH-1 in **Fig. 3**. Clearly that until the depth of 40 m below seabed level, the dominant soil layers are medium to very stiff clay, and in the 21 m or deeper barely any dense silty sand layer is found except at depth 30 to 36 m in which a sand layer is found at the new bore-hole. If the pile to stops at -32 m depth, this means only 2 m of pile toe is covered with sand layer either it is dense or medium dense layer will not give any significant impact to the lateral or vertical bearing capacity. Although the gravelly sand layer is found in the main jetty location, this type of soil will not give a higher friction capacity to the piles, if it is compared to the cohesive soils layer with the same SPT value. The SPT value of this layer is ranging from very low to very high SPT; 10 to 50, and definitely, the thickness will vary as well in the whole main jetty area.

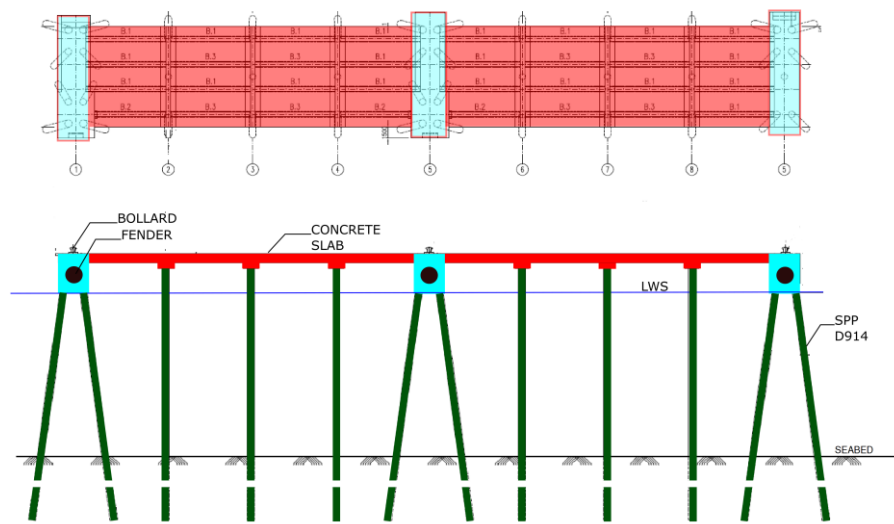
Fig. 4. Main jetty configuration sketch

It can be seen on the main jetty layout presented in **Fig. 4**, the longitudinal pile spacing of 11.5 meters (approximately 12.6D) is considered too large. The consequences

of having an excessive spacing between piles resulting in insufficiency on the number of piles to withstand design loads as follow:

- High displacement of upper structures
- Result in pile overstressed.

The required maximum pile distance is determined through structural analysis. Since it is known that the actual soil condition is much worse than determined on the design; therefore, 12.6D is simply considered insufficient to withstand loads proven with the back analysis result that is further discussed in section 7.

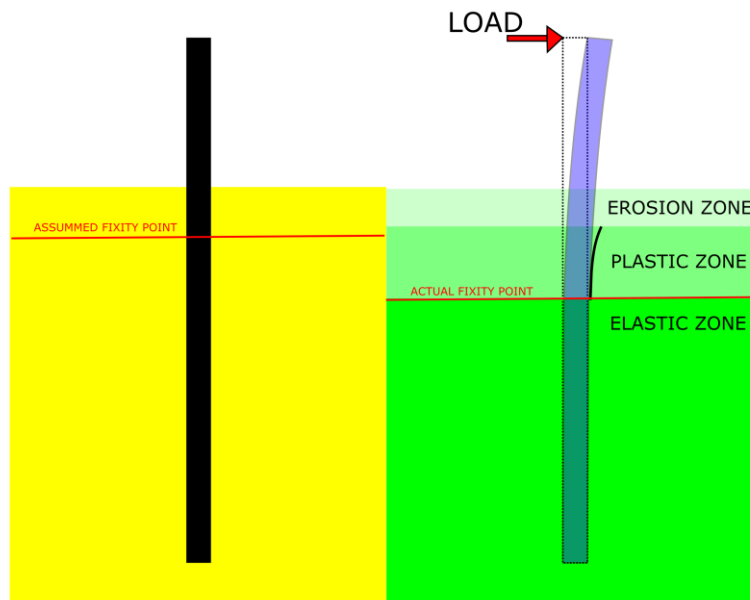
**Fig. 6.** Actual deeper fixity point resulting in higher displacement and bending moment

The higher natural frequency in the initial design means that the structure is more rigid in theory, but not in reality. This issue can be understood since the initial structure is modeled and analyzed based on the ideal geometry as designated (e.g., correct pile raking 1:5, with the ideal free length of piles). The structure was initially designed using the fixity point method, in which the pile zero displacement level is very shallow; hence, it is very optimistic. In the actual situation, many piles are not raking as designated and have longer free length due to deeper eroded seabed. Besides the superstructure structural rigidity, the interaction between the structure and the ground is also important. In this project, the weak ground condition will support the super-

structure badly, resulting in a deeper actual zero displacement level. This can be explained that soil behavior plays an important role in determining the zero-displacement level (fixity point) in the actual condition. Under a certain load, the soil will still behave elastically until a specific load has been reached that makes the soil to enter the plastic state. Once the soil enters a plastic state, theoretically, the strength contribution will be given by the passive soil pressure of the soil itself (Geodelft, 2004). After the load relief, in short term condition, the soil condition will not revert back to the initial condition due to the excessive strains occurred. In other words, the pile loses the grips on the plastic zone. In long term condition, the erosion occurred on the seabed will increase the normative bending moment since the free length of the pile is longer, the actual fixity point will be shifted downward resulting in a deeper point than before. This condition is simply illustrated in **Fig. 6**.

These multiple issues affect the global stiffness of the structure. The structure will deform relatively high even with a small load (e.g., <10 kN), and if it is repetitive loads, such as wave and current, swaying effect may occur.

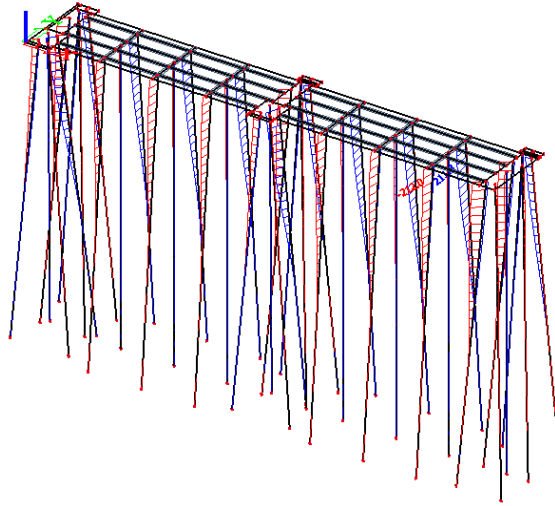
**Fig. 7.** Maximum deflection in Y direction under SLS condition with berthing load

The maximum displacement in-service limit state (SLS) of structure for two chosen load combinations based on BS-6349 (ref.[3]) in the transversal direction is presented in **Table 5**. The first scenario is due to environmental loading included with self-weight with superimposed dead load and live load on the main jetty. The second scenario is similar to scenario one but included with berthing load. Both of two scenarios given are not taken in to account seismic forces. The allowable deflection ( $\delta$ ) is set to 100 mm.

Load combination	Back Analysis (low soil stiffness)	Initial design
	(mm)	(mm)
DL +LL+Environmental load	lower than 20 mm	lower than 15 mm
DL+LL+Environmental load + berthing load	more than 200 mm	lower than 25 mm

Based on two scenarios given, the deflection criteria in SLS condition with berthing load is unsatisfied, and therefore mitigation measures such as additional jetty reinforcement need to be planned if needed. The deflection result of more than >200 mm under SLS condition occurred in transversal (Y) direction parallel with the berthing line, is illustrated in **Fig. 7**.

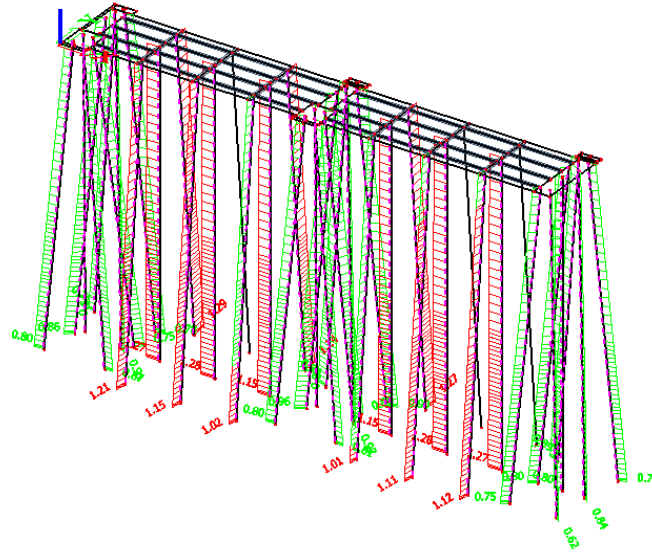
**Fig. 8.** Pile overstress ratio in SLS condition with berthing load

Excessive displacement produced by a high bending moment will result in overstressed pile conditions. From structural modeling, the pile stress ratio is ranging from 0.8 to 1.3 maximum (**Fig. 8**). According to Eurocode 3 (ref. [8]), the maximum allowable pile stress is 1, and obviously, some piles are in overstressed condition. The overstress ratio of 1 means that the occurred stress is equal to the yield of steel. In short-term condition, allowing an overstress ratio to equal to 1 is fine. However, in the long-term situation, this is unfavorable since the steel thickness will decrease over time due to corrosion; and hence, corrosion thickness allowance needs to be taken into account to accommodate the future stress induced on the pile.

From the remodeling result of the existing structure, the 50,000 DWT berthing vessel will induce more than 200 mm displacement to the main jetty. This displacement is exceeded the displacement criteria of 100 mm. A reinforcement effort of the existing structure can be implemented in order to make the jetty operational. The reinforcement can be carried out, especially on the right side of the main jetty, whereas space is available to conduct additional piling works to create the new berthing structures.
