Root cause analysis on failed screws in an industrial turbine

GPPS-TC-2019-083

ROOT CAUSE ANALYSIS ON FAILED SCREWS IN AN INDUSTRIAL TURBINE

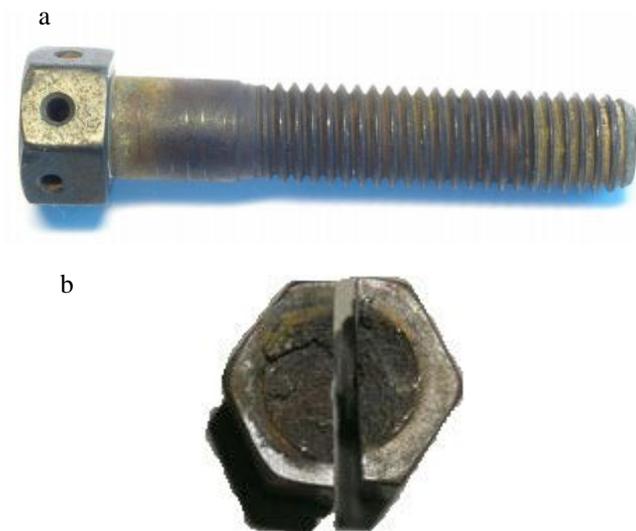
Fig.1a shows screw which was in service. Fig.1b shows head of broken screw that has been cut from middle in order to optical microscopy observation. The fracture surface of the failed screw and unbroken screws was covered by blue/yellow tints oxidized metals.

Fig.1- a) in-service screw, b) head of broken screw

electroplating (Fig.4). It was identified that Observed colourful films (fig.1a) was cadmium oxidized.

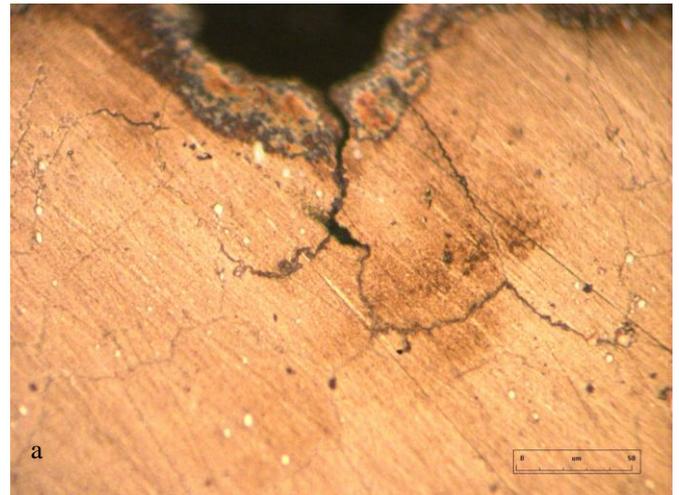
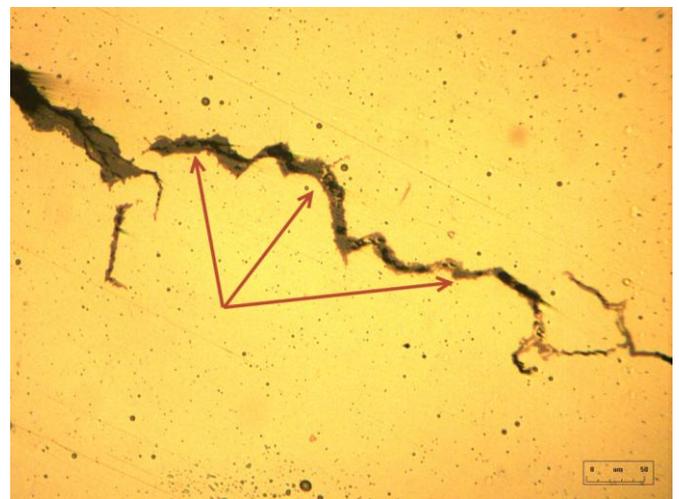
Several intergranular cracks were observed at different zones. These cracks nucleated from outer surface and propagate inward (Fig. 2). The intergranular cracks accompanied metallic oxides are shown in Fig.2b by red arrows.

Fig.2- a) Intergranular crack has nucleated from outer surface, b) propagated crack with metallic oxide

LME is a crack which nucleates as a consequence of liquid metal contact with a base metal. These cracks can quickly embrittle the material and contribute to fracture. Although, metal have a incubation time prior to embrittlement(Metals such as mild steels, low alloy steels, high strength steels, Austenitic stainless steels Seri, Nickel based super alloys, copper, aluminum, and titanium are susceptible to this phenomenon. This phenomenon occur when metals with low melting point such as zinc, mercury, lead, tin, cadmium and copper contact with susceptible metals while temperature is higher than their melting temperature(Lynch, 2008; Lynch, 2003). LME cracks can easily nucleate in interface between low melting point temperature and susceptible metals and propagate under tensile stress. Even a low amount of low melting point temperature metals can stimulate the LME phenomenon in susceptible metals. These cracks can nucleate after a long time of contact between melted metal and susceptible metals (Cameron, 1994). For components that are partially cracked by LME, and then cooled below the melting point of the embrittling metal, subsequent crack extension results in a localized ductile or brittle fracture through the embrittling metal, producing a dimpled or vein pattern on fracture surfaces when the embrittling metal is ductile (Lynch, 1992), *fig. 2* clearly shows these kinds of vein branchy cracks.

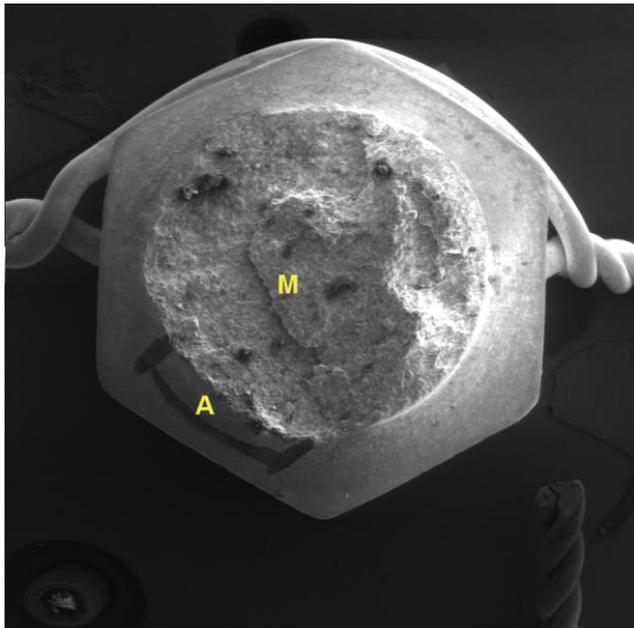
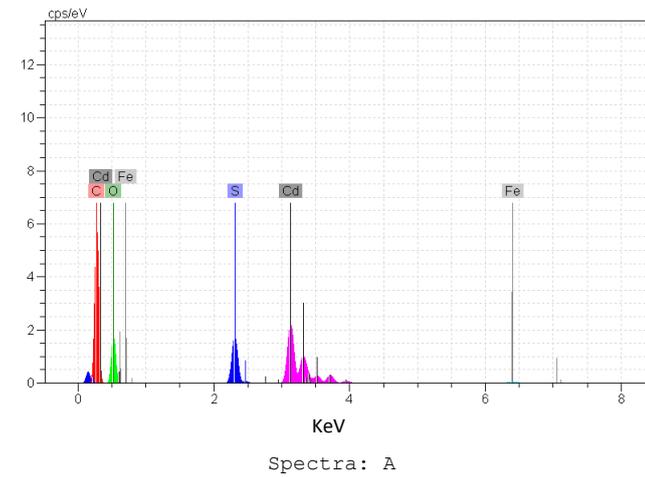
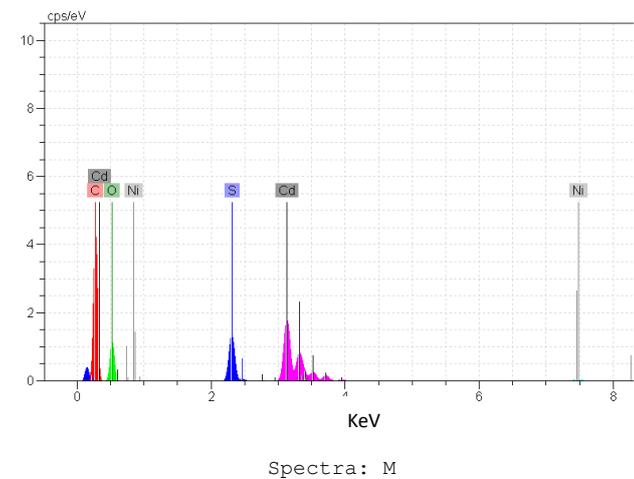
Fracture surface has been analyzed with EDS (Energy-dispersive X-ray spectroscopy) method (Fig. 3). Some elements such as carbon, sulfur, oxygen, and cadmium were detected at points A and M. The source of sulfur, carbon and oxygen were reasonable but the presence of cadmium source is under question. The first two have come from anti-seize material and the last one from atmospheric air.

Fig.3- EDS analysis results of points A and M from broken surface

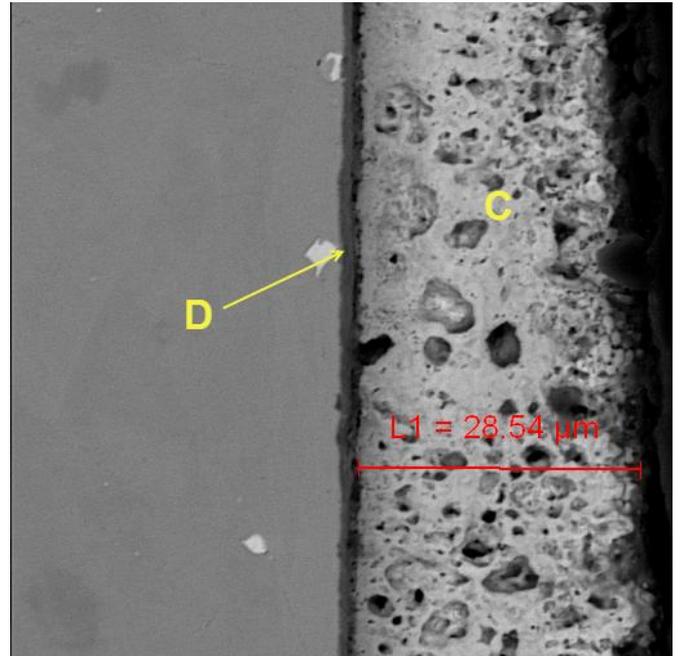
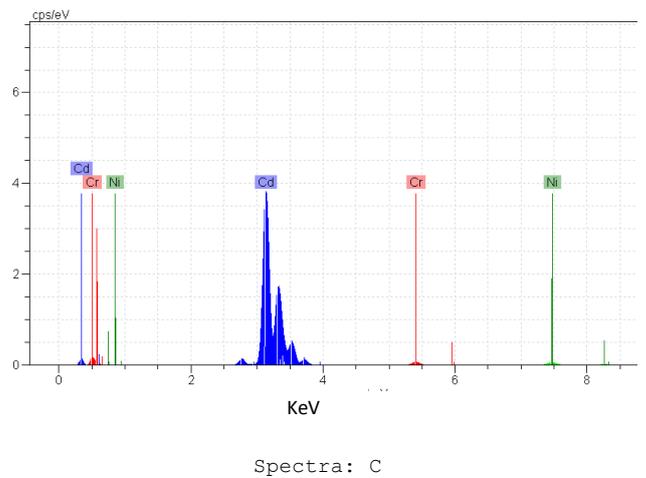
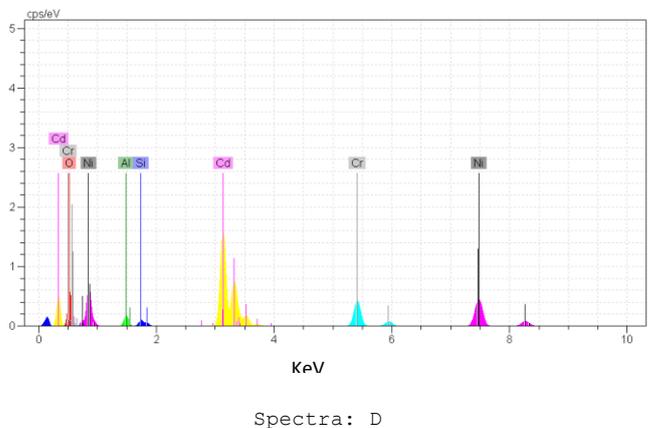
In order to examine more precisely, several other screws were evaluated. The results showed that all of the screws belonged to this machine were coated with Cadmium

Fig.4- EDS analysis results of points A and M from broken surface

Due to the fact that it was supposed to there is not any cadmium coating in the basic design, the investigations were continued to find the source of that. Finally, it became clear that the manufacturer was coated the screws coating bath.

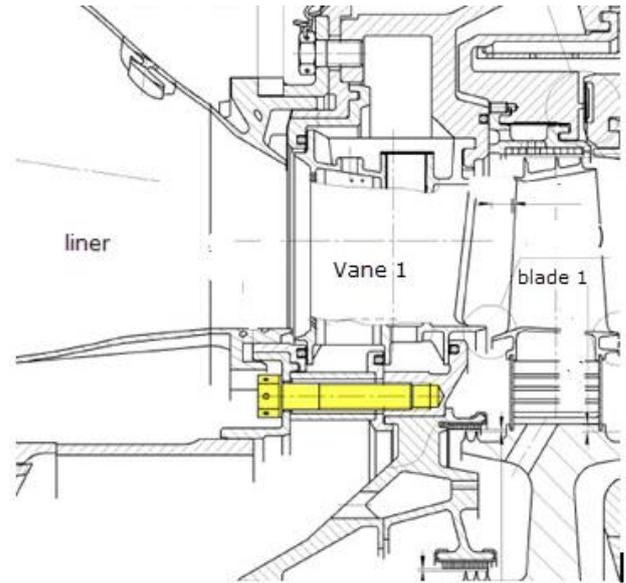
Screws have experienced approximately 500 °C in operation (*Fig. 5*). Since the melting point temperature of cadmium is 230 °C, working temperature lead to melting of cadmium. On the other hand, the hardness about 350 HB, high tension on nickel based super alloy screws and operation mechanical stress; provided a suitable condition for nucleation and propagation of LME cracks.

Fig.5- schematic of assembled screw in hot gas path system

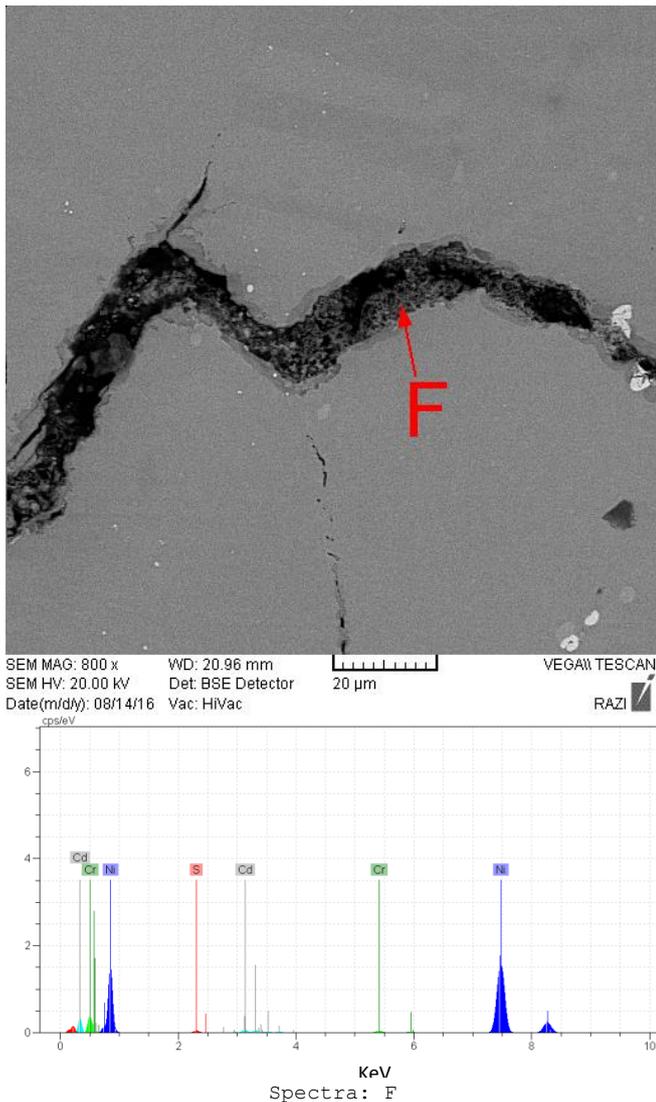
LME occurs when contact with molten material of a lower-melting-point alloy results in a severe reduction in ductility and, very often, strength. This occurs primarily by intergranular entry of the molten metal into a stressed material, effecting progressive separation cracking or grain-boundary decohesion. Cycles of solidification and liquation of the low-melting-point alloy can also affect the extent and speed of this embrittlement, if volumetric expansion occurs during cycles of solidification or liquation. In Figure 6 and EDS analysis result, the presence of cadmium and its progression to the inside of the Intergranular crack is shown. It has been suggested that embrittlement is associated with liquid metal adsorption-induced localized reduction in the strength of the atomic bonds at the crack tip or at the surface of the solid metal at sites of stress concentrations. Adsorption-induced crack growth continues until the supply of liquid metal is ex-hausted, or the stress on the remaining section becomes high enough to produce such rapid overload cracking that capillary flow of liquid metal cannot keep up with the propagating crack. The full LME mechanism has been explained by other researchers (Heloise, 2004 Lynch, 2008; Lynch, 2003; Augera et al, 2014;).

Fig.6-figure and EDS analysis of melted cadmium in intergranular crack is shown

The Screws failure which installed in hot gas path was due to Liquid Metal Embrittlement (LME). No metallurgical and mechanical deviations were found for the screw material with respect to the standard and related documents. It was due to a coating process which caused the entry of the cadmium element into pieces and proceeds to screw failure. Couple material Ni superalloy-cadmium element, innate high temperature of combustor section and static load have resulted in liquid metal embrittlement (LME). Nucleation and propagation of this crack led to failure. It was prevented by replacing them with new uncoated items.
