## Tactile Inspection of Concrete Deterioration in Sewers with Legged Robots

Hendrik Kolvenbach, Giorgio Valsecchi, Ruben Grandia,  
Antoni Ruiz, Fabian Jenelten and Marco Hutter

**Abstract** We present a tactile inspection approach for legged robots which allows for evaluating concrete deterioration in medium to large-sized sewers. The legged robot, to this end, executes a well-defined scratching motion with one limb on the sewer floor. Inertial and Force/Torque sensors implemented in specially designed feet capture the resulting vibration. The data is used with concrete deterioration estimates from professional sewer inspectors to train a support vector machine. We achieved deterioration level estimates within three classes of over 92% accuracy. The dataset, which we recorded during a field test campaign in the sewers of Zurich is made publicly available.

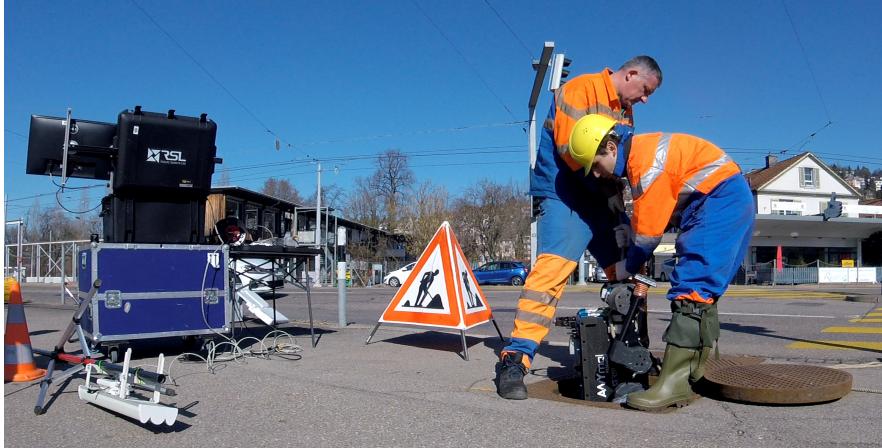
Fig. 4: Depiction of the field test setup and the deployment of *ANYmal* into the sewer. The operator base station and warnings signs are visible in the background.

We conducted multiple field test campaigns in the sewage system of Zurich to iterate the hardware, practice operations and collect datasets. Generally, the robot can be easily deployed through a common utility hole ( $d = 0.8$  m). To do so, the robot's legs are tucked up and the system is lowered into the sewer with a tethered rope (Figure 4). During our tests, the robot was operated from a base station which was located outside the sewer, nearby the utility hole.

The base station consists of the operator PC, an additional screen and outlets for electricity and communication links to the robot. Additionally, the base station is easy to transport and quick to set up. A directional Wi-Fi antenna (Ubiquiti airMAX) was deployed into the utility hole via a tripod with reversed column and enabled a reliable communication link to the robot. During the test, an operator stayed in the sewers with a professional inspector and communicated with the robot operator outside via walkie-talkies (Figure 5).

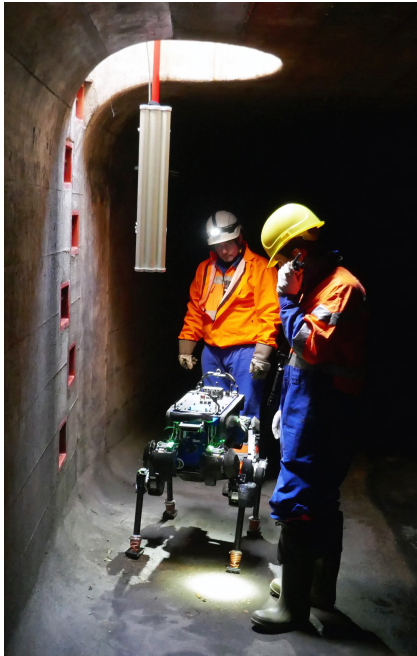
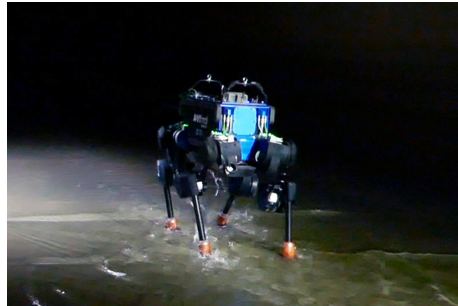
(a) *ANYmal* setup in the sewer

(b) Walking on biofilm

(c) Walking through wastewater

Fig. 5: Depictions of *ANYmal* walking in the sewer. A professional sewer inspector accompanies the testing and assesses the state of the concrete.
