Study on Maintenance System for Cut and Cover Tunnels Showed Signs of Deterioration by Chloride Attack

Masumi Taguchi, Yuji Morohashi, Takuya Chiba,
Hideaki Yamaguchi, Shinji Konishi and Toshiharu Kishi

^{1,2,3,4,5}Civil Engineering Section, Infrastructure Maintenance Department, Tokyo Metro Co., Ltd., Tokyo, Japan

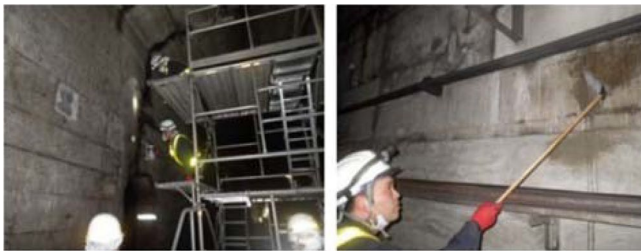
Figure 2: Hammering test/Visual inspection

Silver nitrate solution was sprayed in places where daily inspections revealed deformations in order to confirm whether chloride ions had adhered to the surfaces of those structures. In places where the color changed to white, hammering tests were conducted to check for flaking by checking dull sounds. In places where chloride damage may have occurred, the scope of patch repairs was recorded through field measurements and marking, and used to create a repair development view. In addition, in places where no discoloration of silver nitrate and no chloride damage was observed, the scope of surface impregnation material application was also indicated on the repair development view in an effort toward preventive maintenance. Figure 2 shows hammering test/visual inspection.

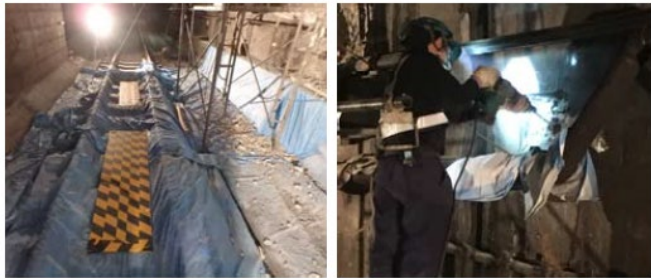
Figure 3: Images of Concrete Chipping

equipment. In order to secure space for the work, chipping was performed to a depth of roughly 20 mm behind the existing rebar. Figure 3 shows images of concrete chipping.

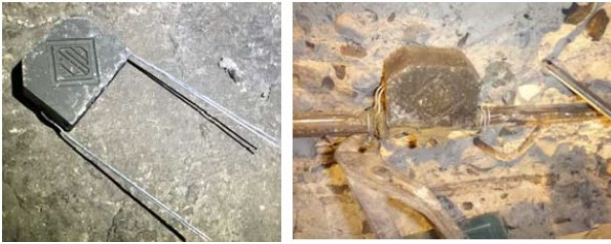
Figure 4: Images of Sacrificial Anode Materials and Installation

Mild steel wire was used to attach the sacrificial anodes to the existing rebar exposed by the chipping work. To improve the electrical continuity between the sacrificial anodes and the mild steel wire, the surfaces of the rebar where the wire was to be connected were thoroughly prepared. Sacrificial anode spacing was determined based on calculations of the surface area of rebar per square meter of structure and the corrosion prevention radius (Figures 4, 5, and 6).

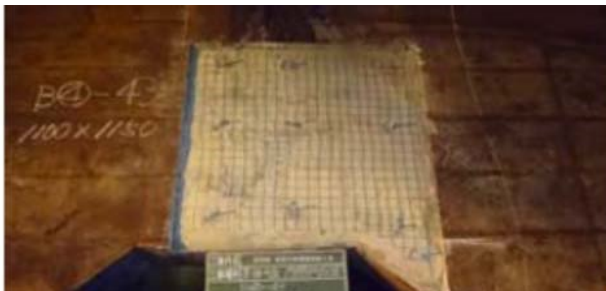
Figure 7: An Installed FRP Grid

In addition, an FRP grid was used to prevent the mortar from peeling or falling off, and anchor bolts and washers were used to secure the FRP grid to the existing structure. The use of carbon fibers, which conduct electricity, in the FRP grid was avoided to prevent the protective current from leaving the target area. When the depth of the patch repairs to be repaired was 80 mm or less, single layers of FRP grid and mortar were used; when the depth exceeded 80 mm, two layers of each were used. Figure 7 shows an installed FRP grid.

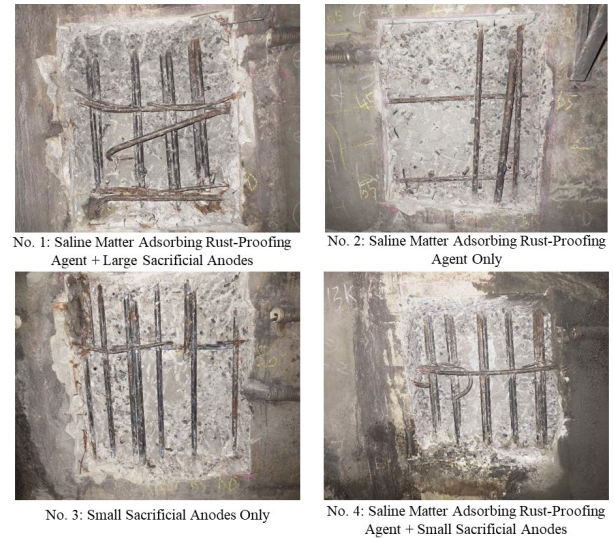
Figure 14: State of Rebar Corrosion

Figure 14 shows the state of the rebar. Our visual inspections did not reveal any corrosion of rebar at or around the places where sacrificial anodes were installed at No. 1, No. 3, and No. 4. However, we did confirm significant corrosion of rebar in some places within the scope that were not repaired. At No. 2, where only the rust-proofing material was used, we confirmed that the patch repair of some of the rebar in the scope of repairs had decreased, and we noted the same trend at places within the scope that were not repaired at No. 1, No. 3 and No. 4.
