## A Brief Analysis of the Leaching Process in the Backfill Concrete of a Powerhouse

Claudio Neumann Junior, Ana Carolina Parapinski Dos Santos  
and Etoe Funchal de Faria

**Keywords:** Leaching in Dams; Structure Aging; Durability of Concrete

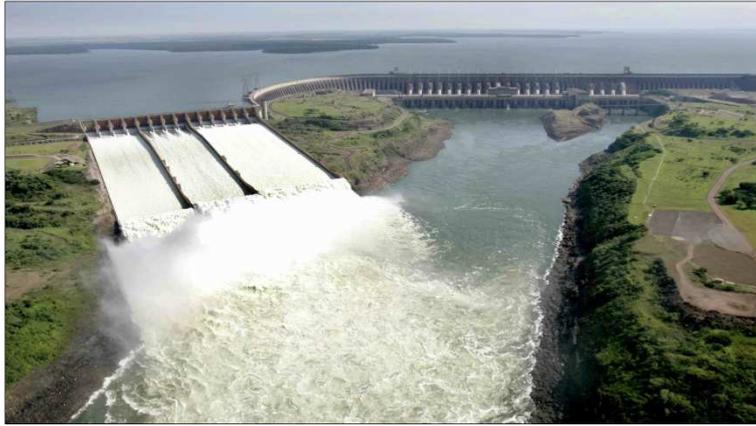
Figure 1: General view of Itaipu power plant.

Itaipu Hydroelectric power plant is a binational entity located at Paraná River, on the border between Brazil and Paraguay (Figure 1), built between 1975 and 1982 by both countries. It has 20 generators, 16 of them in the power house of the main bed of the river and 4 others in the Diversion Channel. With 14,000 MW of installed power, it supplies about 15% of the energy consumed in Brazil and 75% of that consumed in Paraguay.

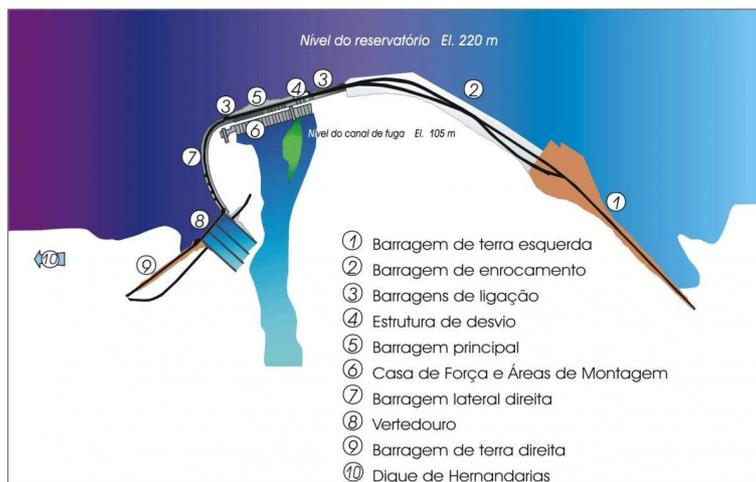
Figure 2: Itaipu complex plant.

The dam is approximate 7,700 m long and has a maximum height of 196 m. Its structure is composed by five kinds of dams: the rockfill dam, formed by a core of compacted clay, lined with rock blocks from the Diversion Channel excavations; the earth dam made of clay from the excavations of the rockfill foundation and its neighbor areas; and concrete of the hollow gravity, gravity dam and buttress dam.
