## Assessment and Back Analysis of a Swaying-Jetty in Dumai Indonesia

Merdeka Tazakka, Adecar Nugroho and Budiwan Adi Tirta

January 29, 2020

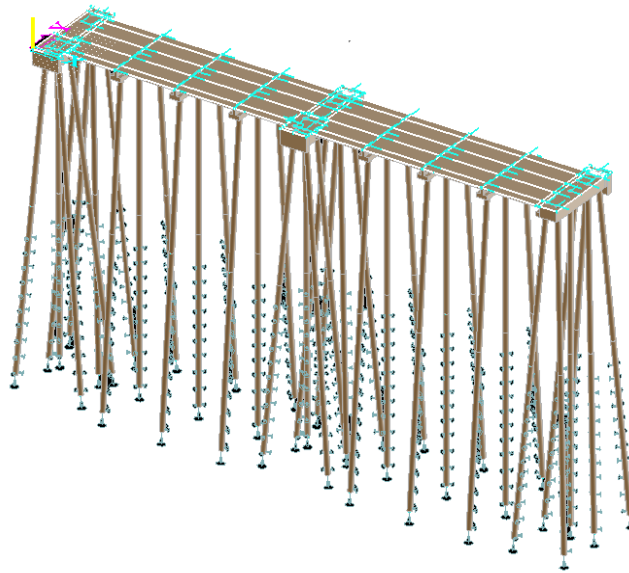
**Fig. 5.** Structural geometry of back analysis model of the main jetty

6 vertical piles and 76 inclined (1:10) piles with 914 mm diameter and 14~16 mm thickness are used in the model. The inclination in the model is based on actual field measurement. The jetty consists of a 300 mm thick concrete slab (consist of 150 mm precast and 150 mm in-situ) supported by grids of concrete beams.
