Steel Impact and Fire Behaviour in Overheight Vehicular Bridge Accidents

Steel Fire Behaviour in Vehicular Bridge Accidents

This paper presents a case study for assessment of possible changes in critical materials properties in the fire event on a bridge. Also, the paper highlights the need for a comprehensive guideline to bridge fire damage assessment and repair, depending upon the bridges' traffic functionality. This in turn may result in improving the bridge design strategies from fire safety perspective.

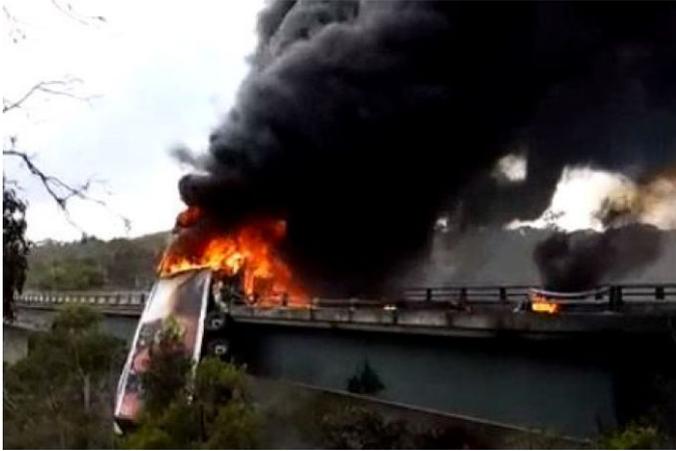
A B-double truck crashed into a bridge in southern region of NSW, Australia. It was hanging over the side of the bridge after hitting the traffic barrier and igniting into flames. Fig. 1 is a photo taken by Australian Broadcasting Corporation (ABC) from the incident [11].

Fig. 1. ABC News photo from the truck crash and fire incident, south of Sydney, NSW [11].
